CALIFORNIA DIVISION OF MINES AND GEOLOGY
FAULT EVALUATION REPORT FER-185

SURFACE RUPTURE ASSOCIATED WITH THE NORTH PALM
SPRINGS EARTHQUAKE OF JULY 8, 1986--BANNING AND
RELATED FAULTS, RIVERSIDE COUNTY

By James E. Kahle, Earl W. Hart,
Glenn Borchardt, and Michael W. Manson
August 7, 1987

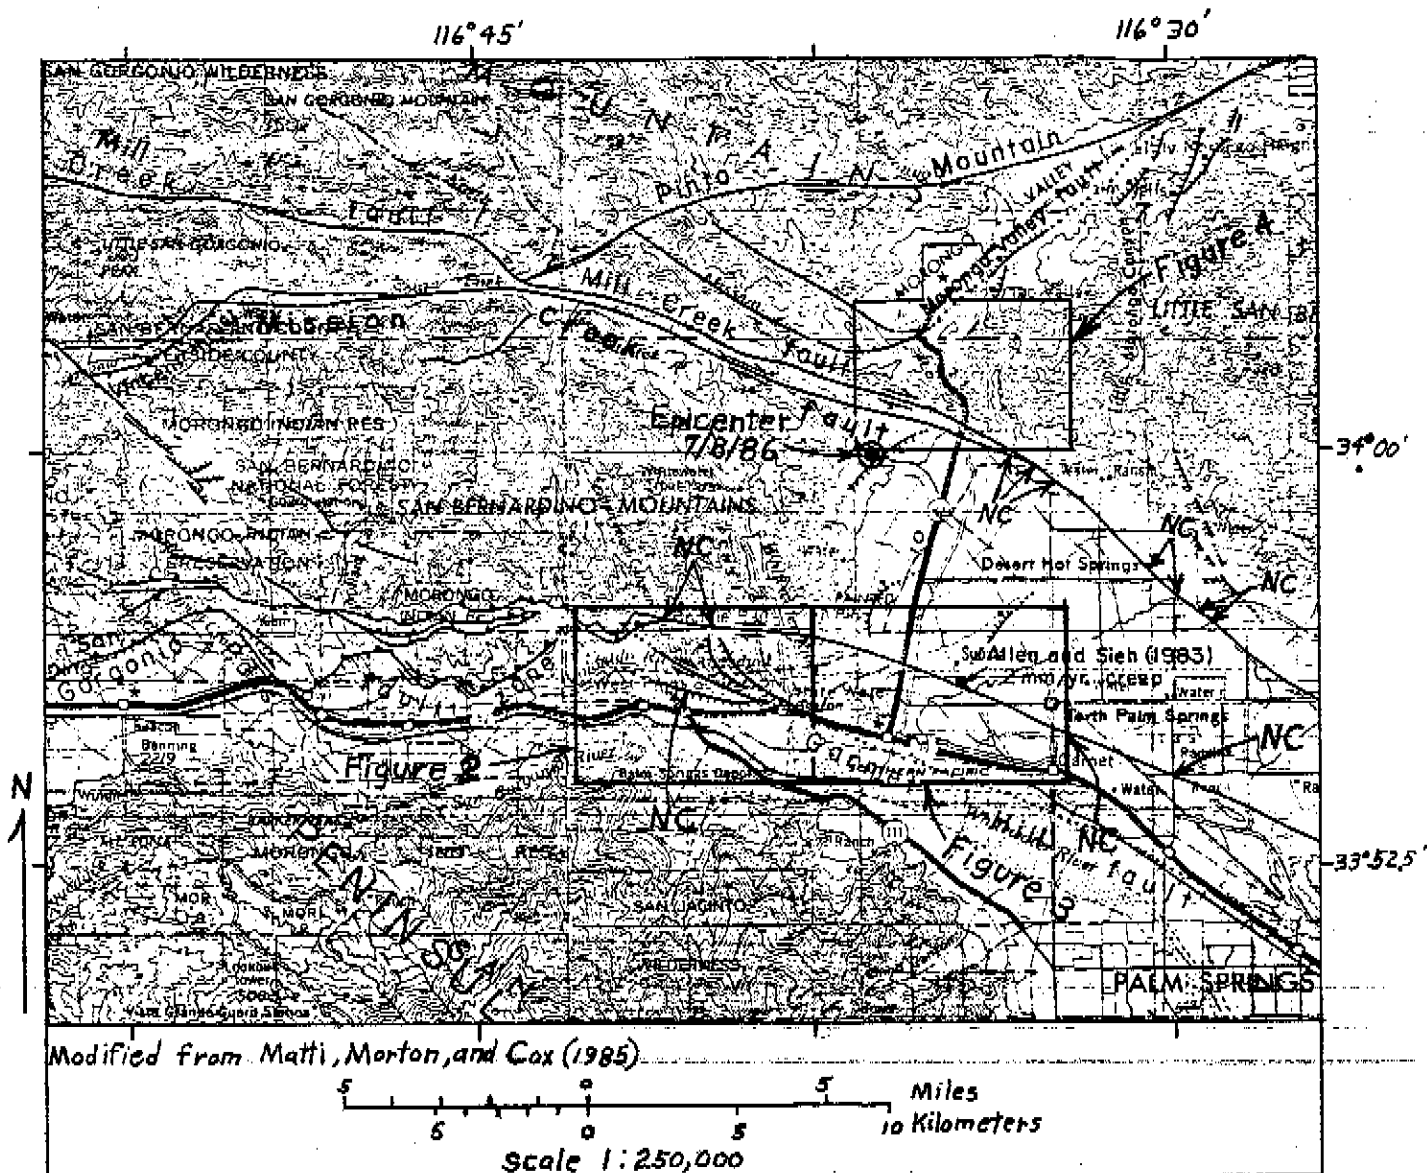
Garnet Hill Fault (Figure 2)

- (22). Cracks along [pre-existing] broad, south-facing scarp in older alluvium of Whitewater Canyon. Cracks found in a zone up to 10 m wide marked by both compressional and tensional features. Both roads which cross the scarp are paved and both were broken. The western road (Whitewater Canyon Road) had a compressional hump with 2-3 cm of overlap, north side up. Similar cracks were seen to the east along the scarp in alluvium. The hump in the eastern, branch road had about 6-7 cm of overlap, north side up, and similar reverse faulting was seen along the scarp to the east. Numerous boulders along the scarp were tossed or rolled from their resting places.
